RUPPAIR®

CASE STUDY APPLICATION

HOTEL CORRIDOR REPLACEMENT

RUPPAIR'S HVAC UNIT

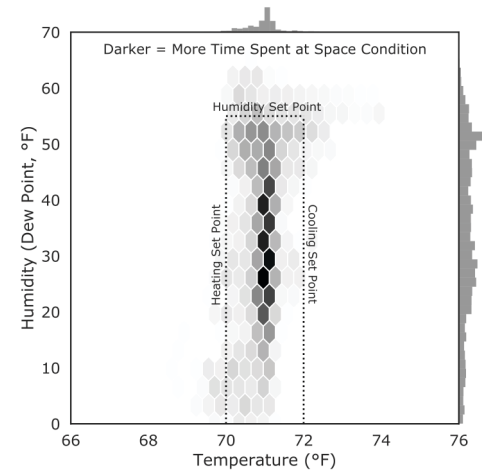
Space Conditions Relative to Set Points

Performance data over three months since commissioning in mid-September reveal a successful outcome. While operating 24/7 at 100% outside air:

- Space temperatures always remained within 1°F of the set points
- Space humidity (dew point temperatures) did not exceed 3°F of the setpoint over 99% of the active cooling period
